Raised Access Floor
Short Analysis
By

Overview

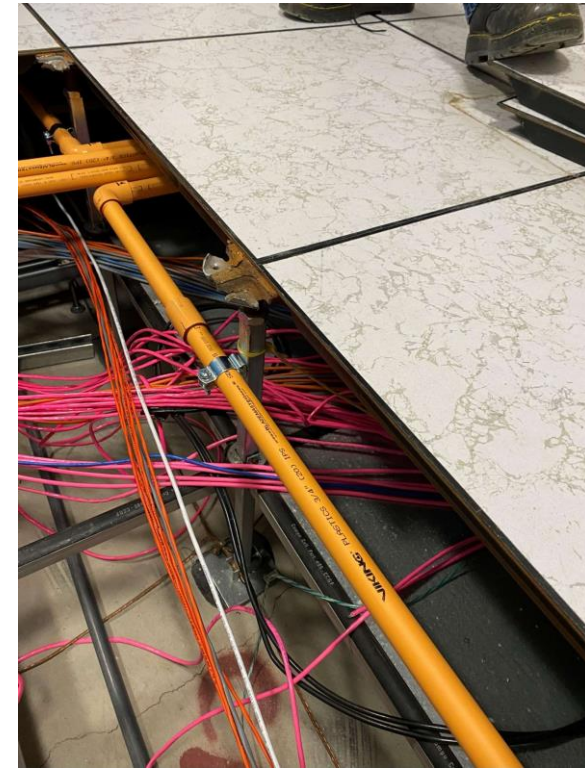
This image shows the style system that is in the entire A and B Farms as well as the P room. As seen in the picture this is a stringerless system. This style system produces many challenges such as tiles dropping into the subfloor, lack of structural stability with rolling loads.

Our recommendation would be a Tate Concore 1250 tile with a bolted stringer system, even though not illustrated here, we would use a 4' stringer with a basket weave installation.

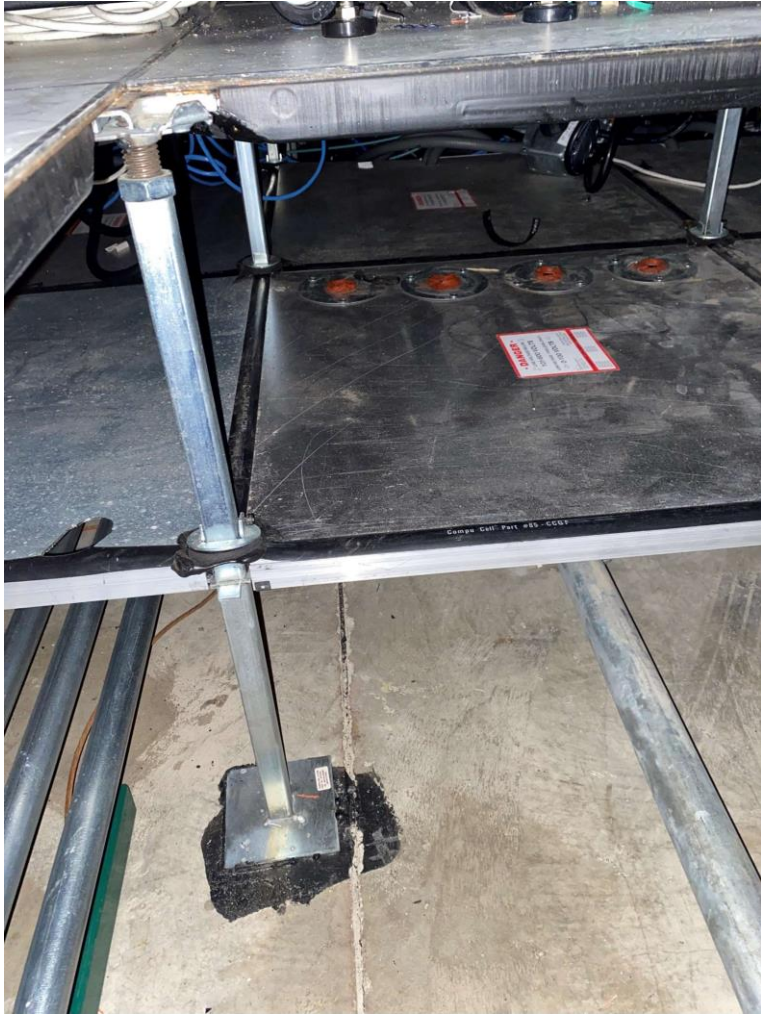
These two pictures identify the secondary level for cable tray and power distribution. The system is directly attached to the pedestal system, this addition does not assist the structural integrity of the system, it simply acts as a distribution system.

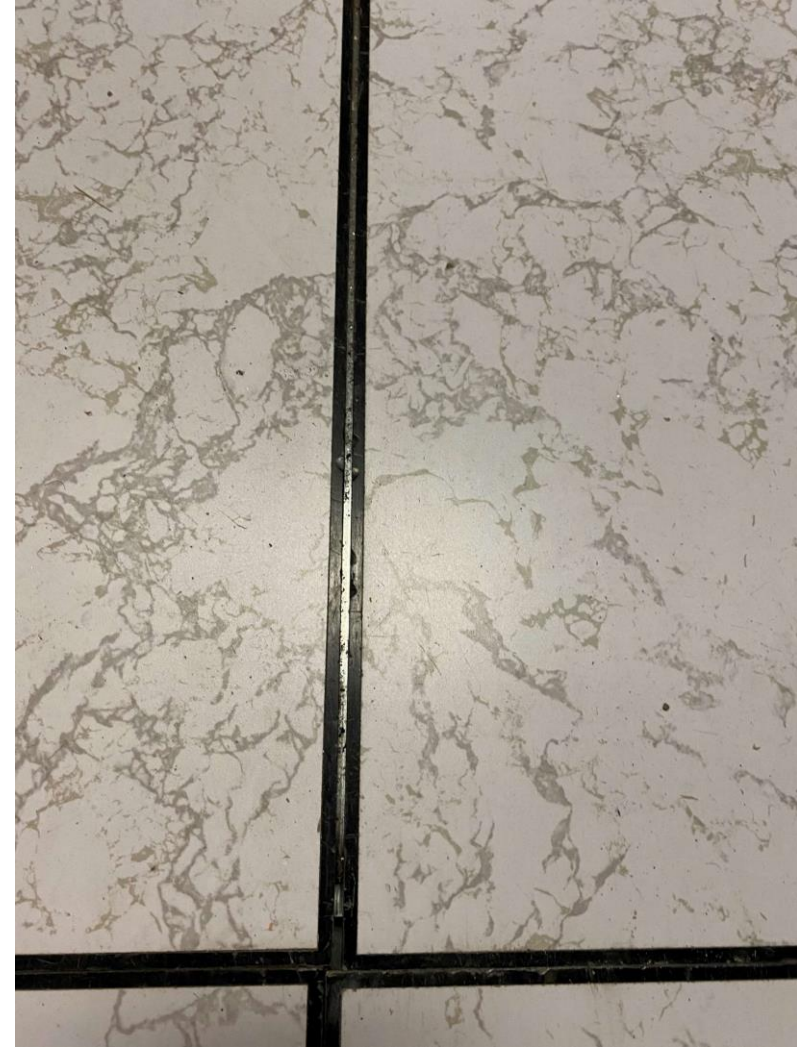
In these two pictures we see a gap between the tiles, this is of concern since this system has no stringers, this leaves the system to hold on to an edge of a pedestal head on a corner of the tile. With the amount of work continuing to occur in these areas brings concern with regards to the integrity of the floor. Possible results can be equipment falling in the floor, or a person.

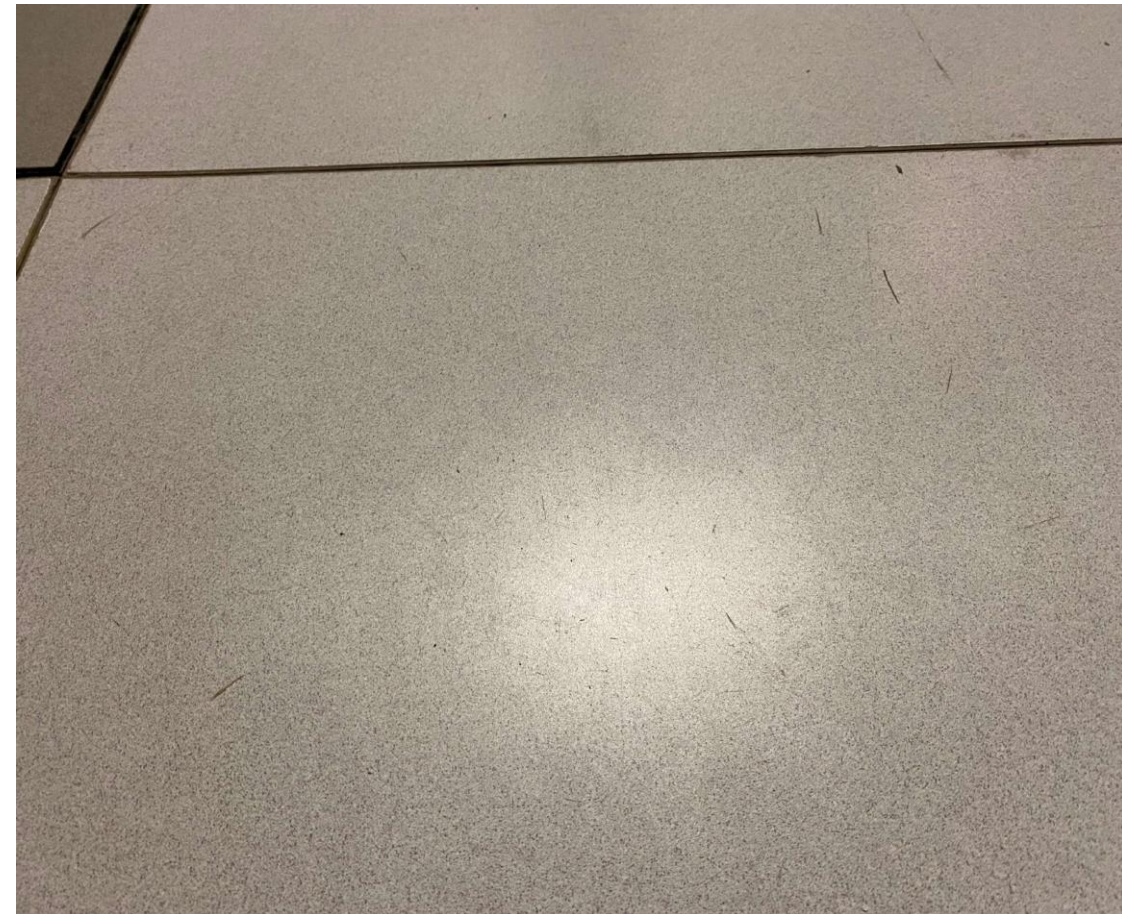
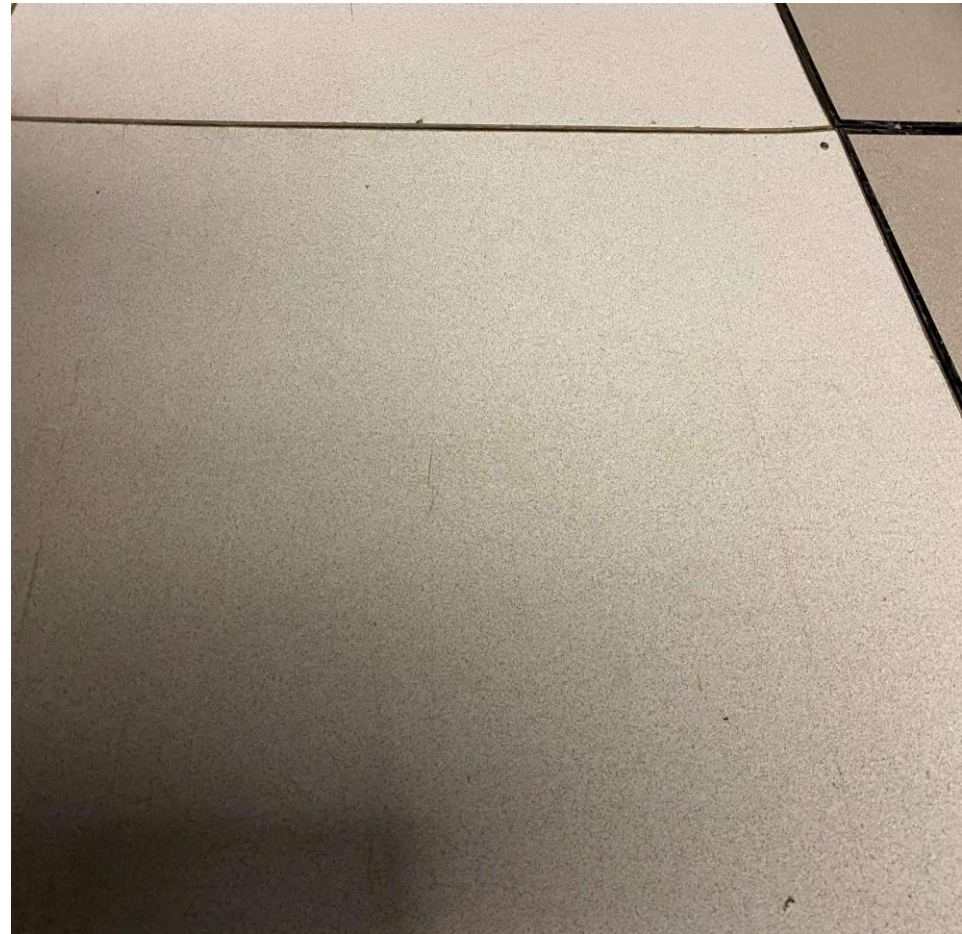
These two illustrate the cupping/dishing of the tiles as well as the loss of laminate adhesion. This typically occurs as part of the end-of-life cycle of the floor tiles.

- With all the upgrade work occurring in these rooms, it looks as if these rooms will continue to be used for years to come.
- It would be a good time to upgrade the existing floor, the pedestals seem to be in good shape, this would mean removing the existing pedestal heads, old tile and replacing these with new heads, stringers, and tiles. This can be done with lifting the equipment where possible live and replacing as much of the flooring as can be. Where equipment cannot be lifted, add supports to create an island that can sustain itself weight load wise.

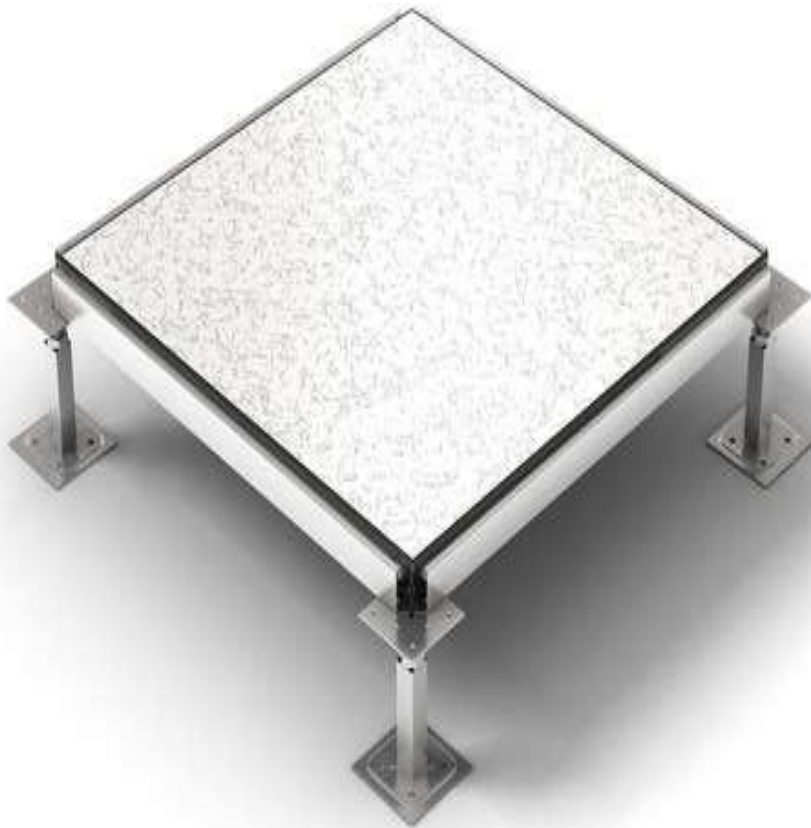
- Panel weight : 8 lbs/ft² bare
- All steel welded construction filled internally with a cementitious core material
- Protected from corrosion by an epoxy paint finish
- Class A flame spread rating
- Non-combustible material
